Flash 7000 Installation Manual

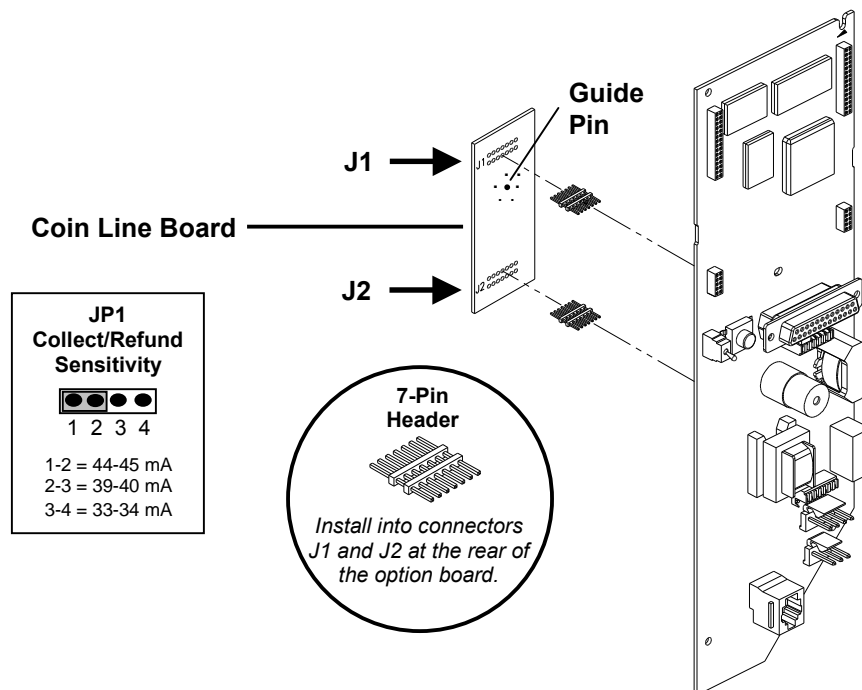
7. Mount the coin line option board to the rear of the chassis assembly such that the 7-pin header attached to connector **J1** of the option board installs into the holes that correspond to connector **JD1** at the rear of the chassis assembly (the letter designation **JD1** can only be viewed from the front of the chassis assembly.) The 7-pin header attached to connector **J2** on the option board should align into the holes that correspond to connector **JD2** at the rear of the chassis assembly. The guide pin attached to the rear of the coin line board should align into the guide hole at the rear of the chassis.

8. Secure chassis PCB to the chassis housing.
9. Reinstall the chassis assembly into the lower housing.
10. Reinitialize the phone. Then, secure the upper and lower housings of the phone together.

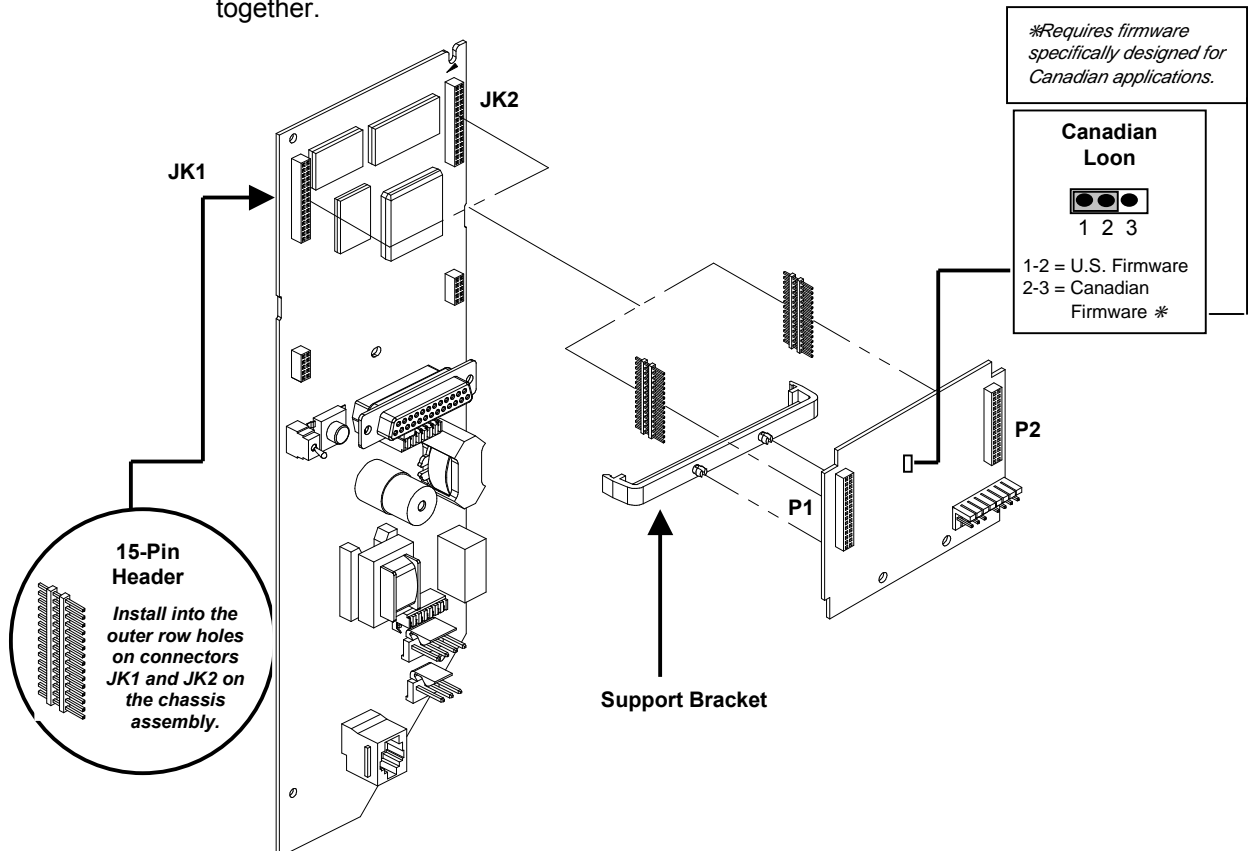
Appendix J - Installing the ECS Option Board

6. Mount the ECS option board to the front of the chassis assembly such that the headers attached at connectors **JK1** and **JK2** install into the outer most holes of connectors **P1** and **P2** of the option board. Then, secure the option board support bracket to the chassis assembly.
